TELEVISION

AND HOME ELECTRONICS REPAIR

DECEMBER 2003 £3.20

Vol. 54, No. 2

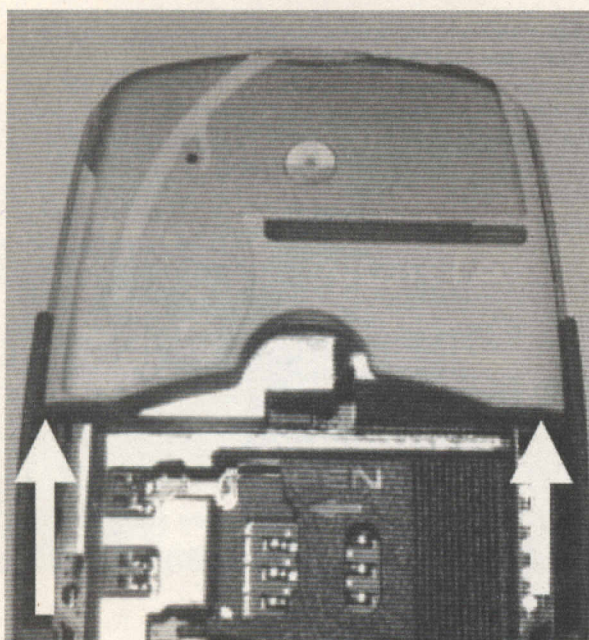
Fig. 1: Aerial removal, Nokia Model 3210.

case where the aerial emerges or a snapped aerial. A broken aerial can be removed by using a pair of pliers to squeeze its base, inside the case, to compress the retaining lug then pushing the aerial upwards. Make sure that the replacement is of the correct type – the 900MHz and 1.8GHz versions look the same but are different internally.

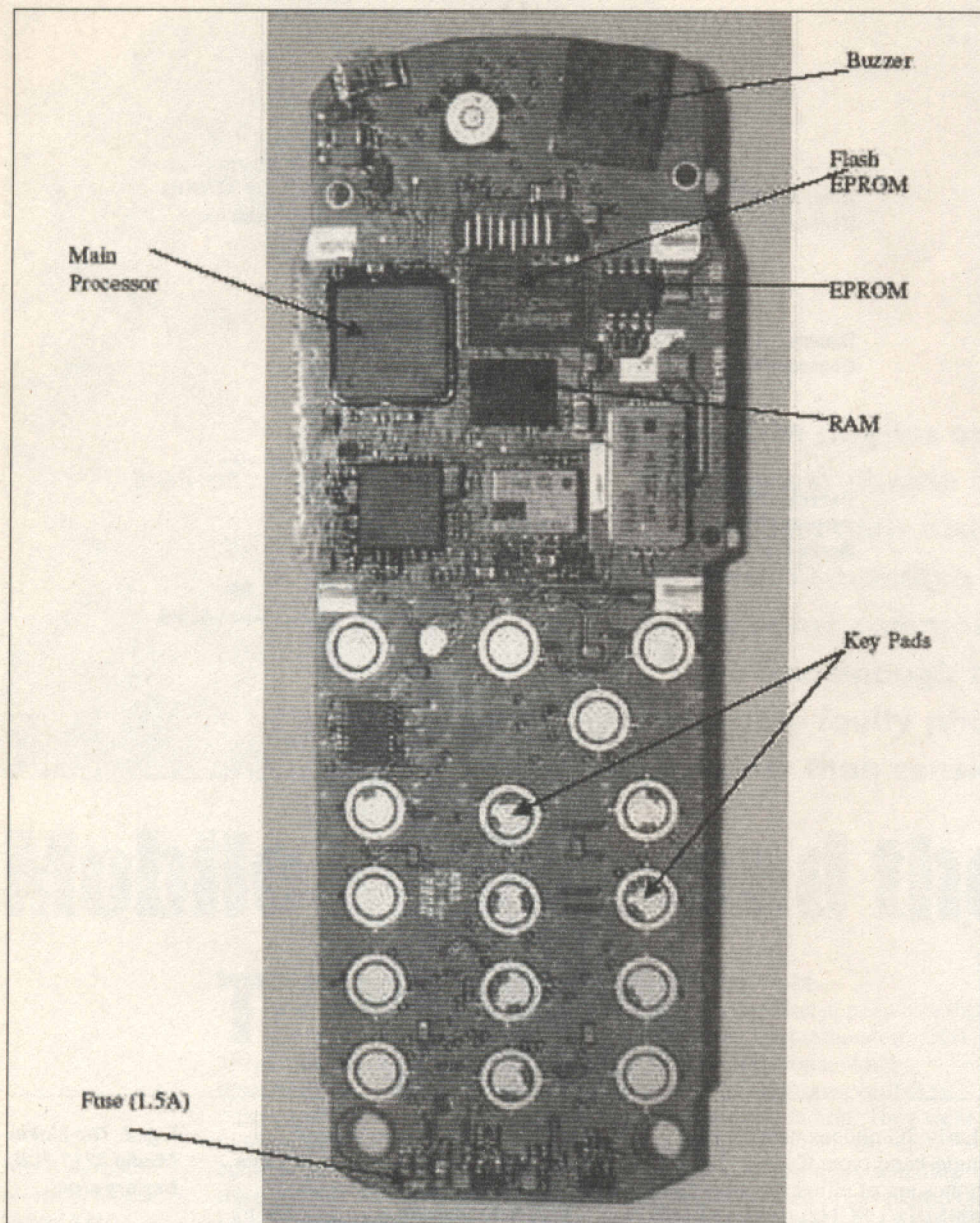
Fig. 3: The Nokia Model 3210 PCB, keyboard side.

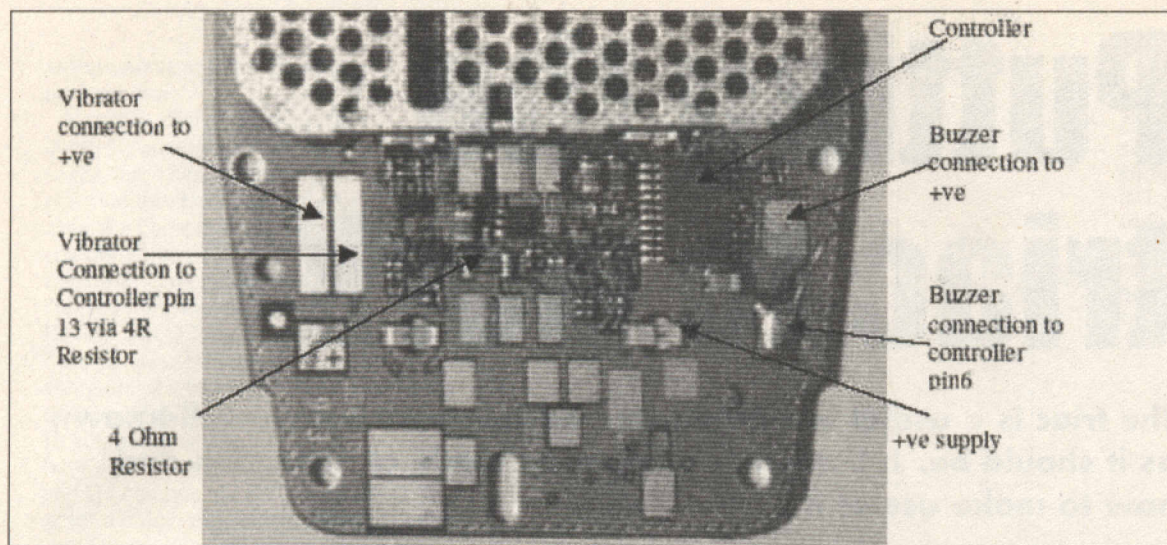
Fig. 4: PCB in the Nokia Model 3310, showing the vibrator connections.

A recurring problem with these phones is failure to ring or vibrate. Before you start fault-finding, a quick check on the menus is always worthwhile. It may just be that the phone has been set to silent or vibrate has been disabled. If this fails to produce the solution, check the vibrator-motor connectors. These are long, thin metal strips that make contact by pressure on the PCB. If a phone has been dropped, the contactor may have bent so that it no longer makes contact. If this proves to be OK, check the vibrator momentarily with a DC source of about 3V. Finally, check the continuity between the positive supply and the ringer/vibrator, also the connections to the controller IC. I've come across many cases where these PCB connections have failed – I can only assume that this is related to the track thickness and the current required to drive these devices. If these connections are faulty, a thin wire such as a Verowire pen will be needed to bridge the gap. In Fig. 4 I have added a wire from the ringer pad to pin 6 of the controller IC to overcome this problem. ■

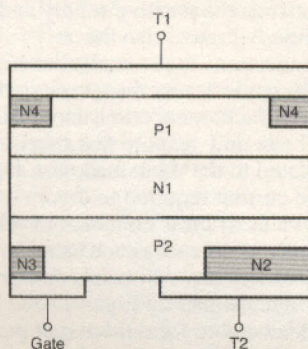
Fig. 1: Basic structure of a triac.

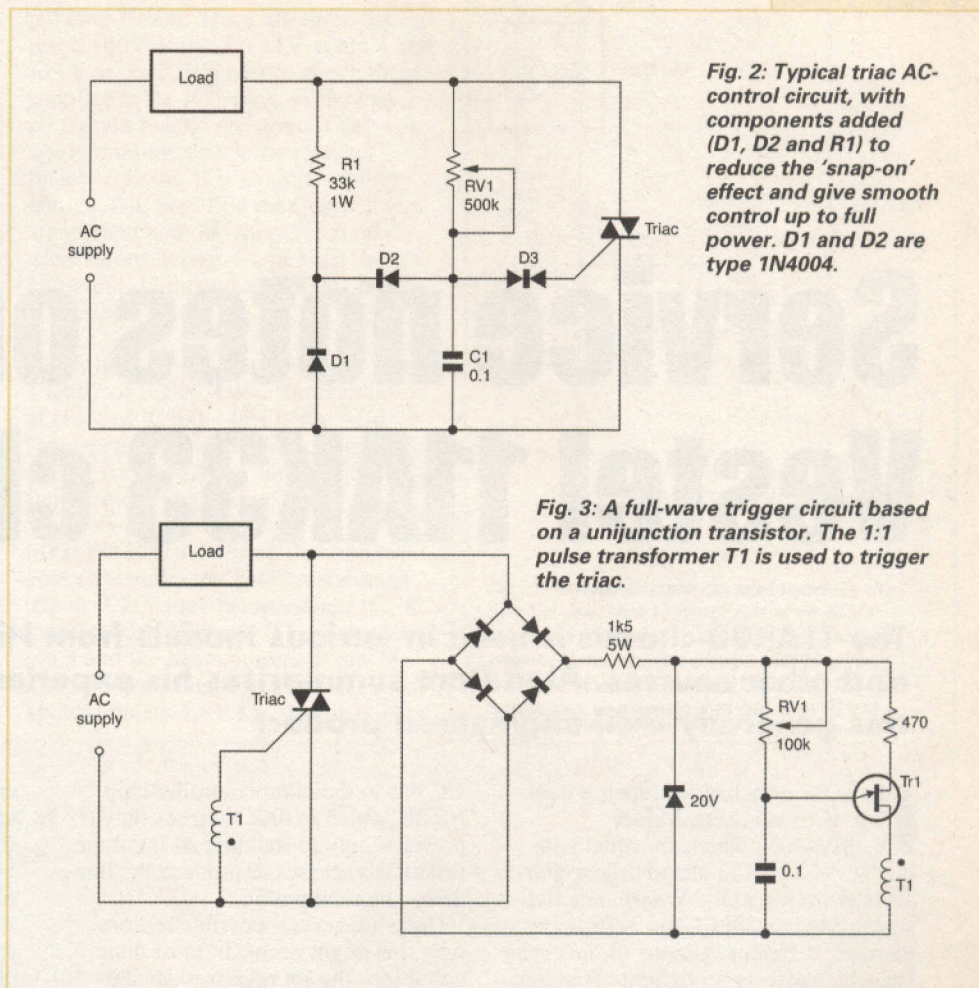
Fig. 2: Typical triac AC-control circuit, with components added (D1, D2 and R1) to reduce the 'snap-on' effect and give smooth control up to full power. D1 and D2 are type 1N4004.

A simple charging circuit for control can cause abrupt triggering when attempting to raise the power in the load from zero to a chosen level, with smooth adjustment over the range thereafter. To counter this effect and provide smoother operation, R1, D1 and D2 are added to the basic circuit. The diodes reset the charge on the capacitor at the end of each positive-going half cycle. During the positive half-cycle both diodes are reverse biased and C1 charges via RV1. At some point the diac triggers the triac. As the supply voltage falls during the second quadrant of the AC cycle, a point will be reached where the voltage at the cathode of D2 falls below that across C1. D2 will then conduct, discharging C1 via R1. When the mains supply crosses the zero point and becomes negative, D1 conducts and C1 charges to a negative voltage. No reset occurs at the end of the negative half-cycle. A reduction of the 'snap-on' effect can also be obtained by connecting the 'hot' end of RV1 to the supply side of the load, though this may not be convenient when controlling remote items such as lighting.

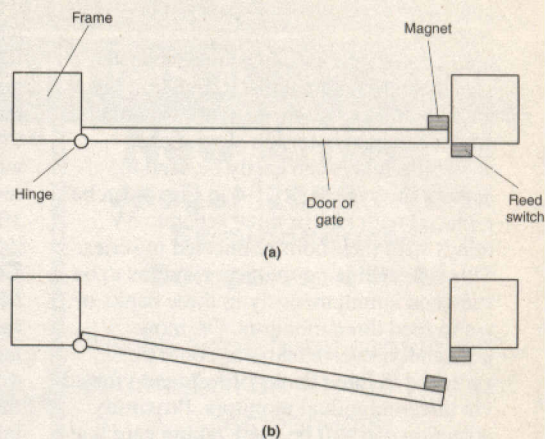
Fig. 10: Momentary-closed operation of a reed switch for proximity detection. (a) Door closed, reed switch open. (b) The reed switch momentarily closes as the door is opened (and closed).

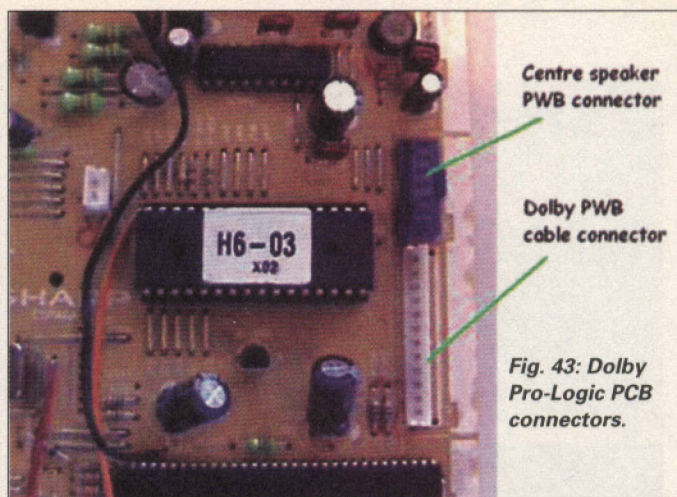
Fig. 43: Dolby Pro-Logic PCB connectors.

With an incorrectly operating or dead set the Dolby Pro-Logic PCB can be ruled out as a possible cause simply by disconnecting it from the main PCB. This is easily done by disconnecting the large multi-way cable from the main PCB, see Fig. 43. The set should then start up normally, but there will be no sound if the

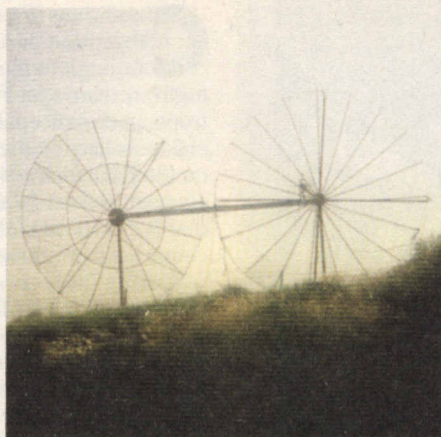
Photo 1: Large skeleton dishes used on the Laois/Kilkenny border in Southern Ireland to receive BBC and ITV transmissions from Wales.

On a recent visit to Southern Ireland I took the two photos shown alongside, Photos 1 and 2. They were taken on the

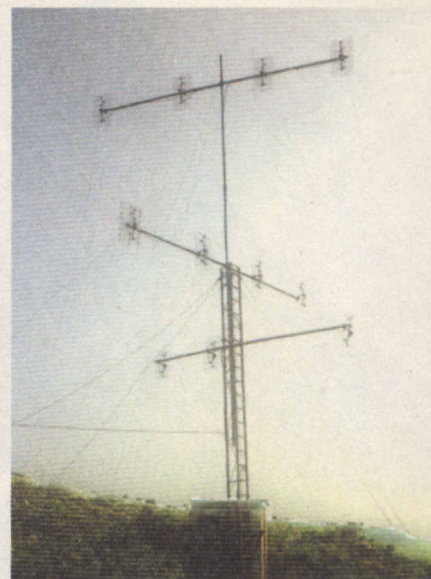
Photo 2: Stacked bow-tie aerial systems used to retransmit the signals to local residents.

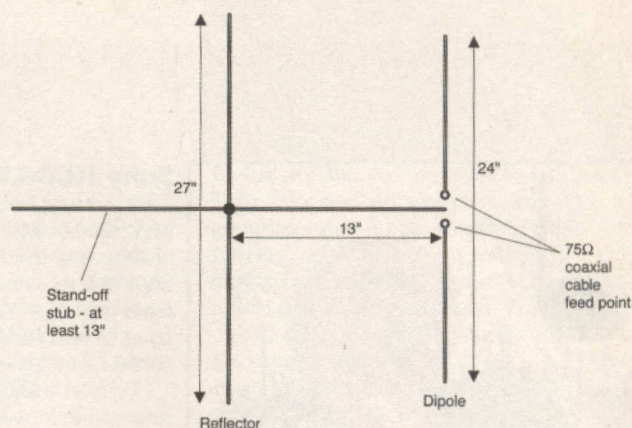
Fig. 1: A simple DAB-band aerial that covers 217-230MHz. Mount the aerial vertically. The output impedance is approximately 60Ω. Use materials as available – an FM aerial is ideal. 1in. outside-diameter aluminium tube is suggested for the boom, 0.5in. OD aluminium tube for the elements.

Fig. 1 shows a simple vertically-polarised two-element aerial that covers 217-230MHz. It provides a gain of about 2.2dBd, a

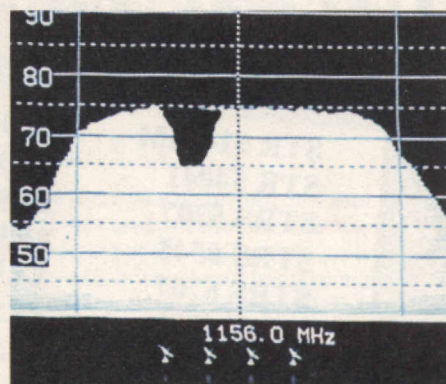
Photo 1: Spectrum-analyser display showing a distinct dip in the transponder 54 frequency response.
